DOT/FAA/CT-94/89

# Corrosion of Fire-Damaged Aircraft

April 1995

Final Report

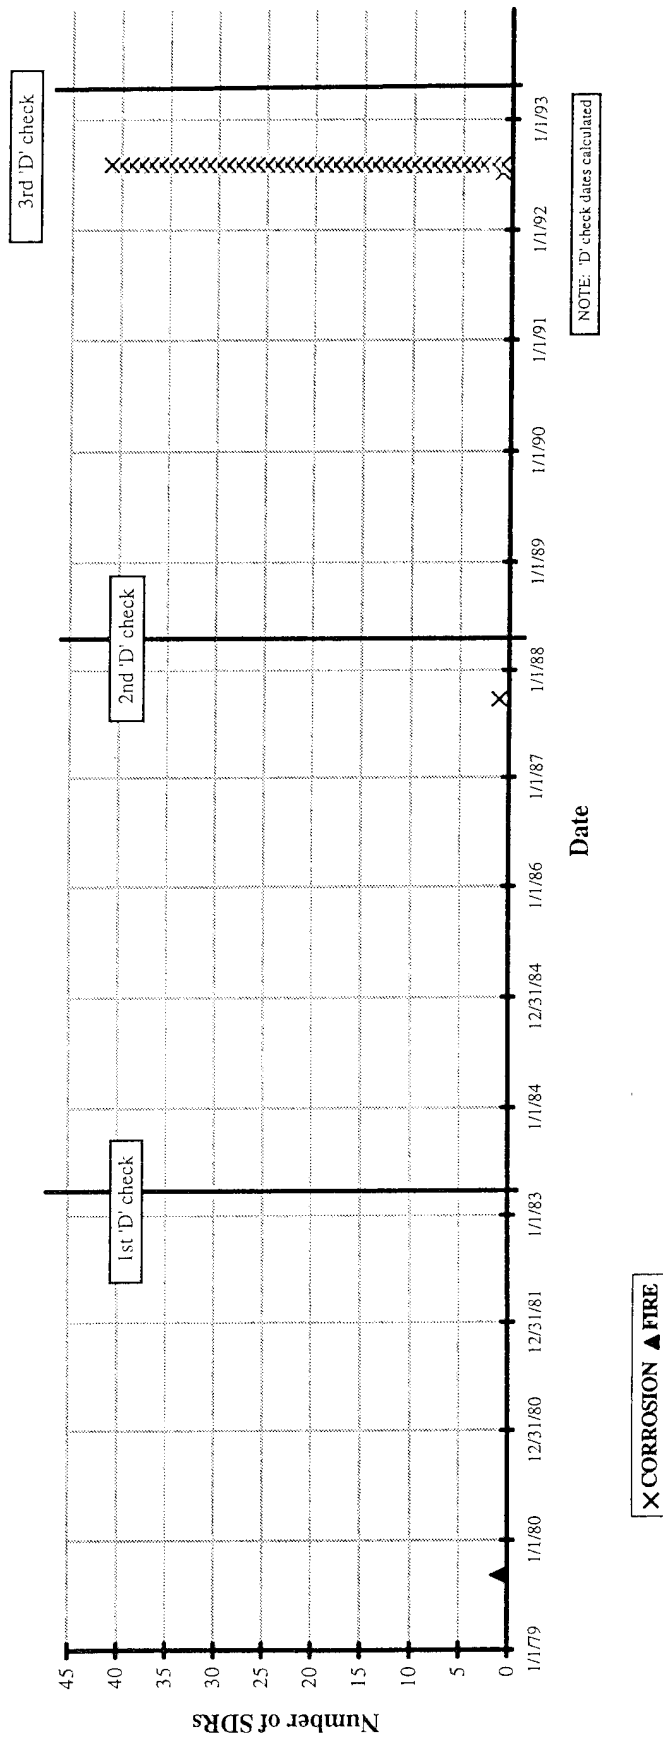
FIGURE 1. B727, S/N 21483: FREQUENCY OF CORROSION SDRs BEFORE AND AFTER A FIRE EVENT

The 727 showing the most likely fire/corrosion relationship is S/N 21483. Data shown in figure 1 shows a possible fire/corrosion relationship, a fire in 1979 followed by high corrosion events reported 13 years later in 1992. Also, the first major incidence of corrosion reporting in 1992 occurred when the aircraft was less than 15 years old.

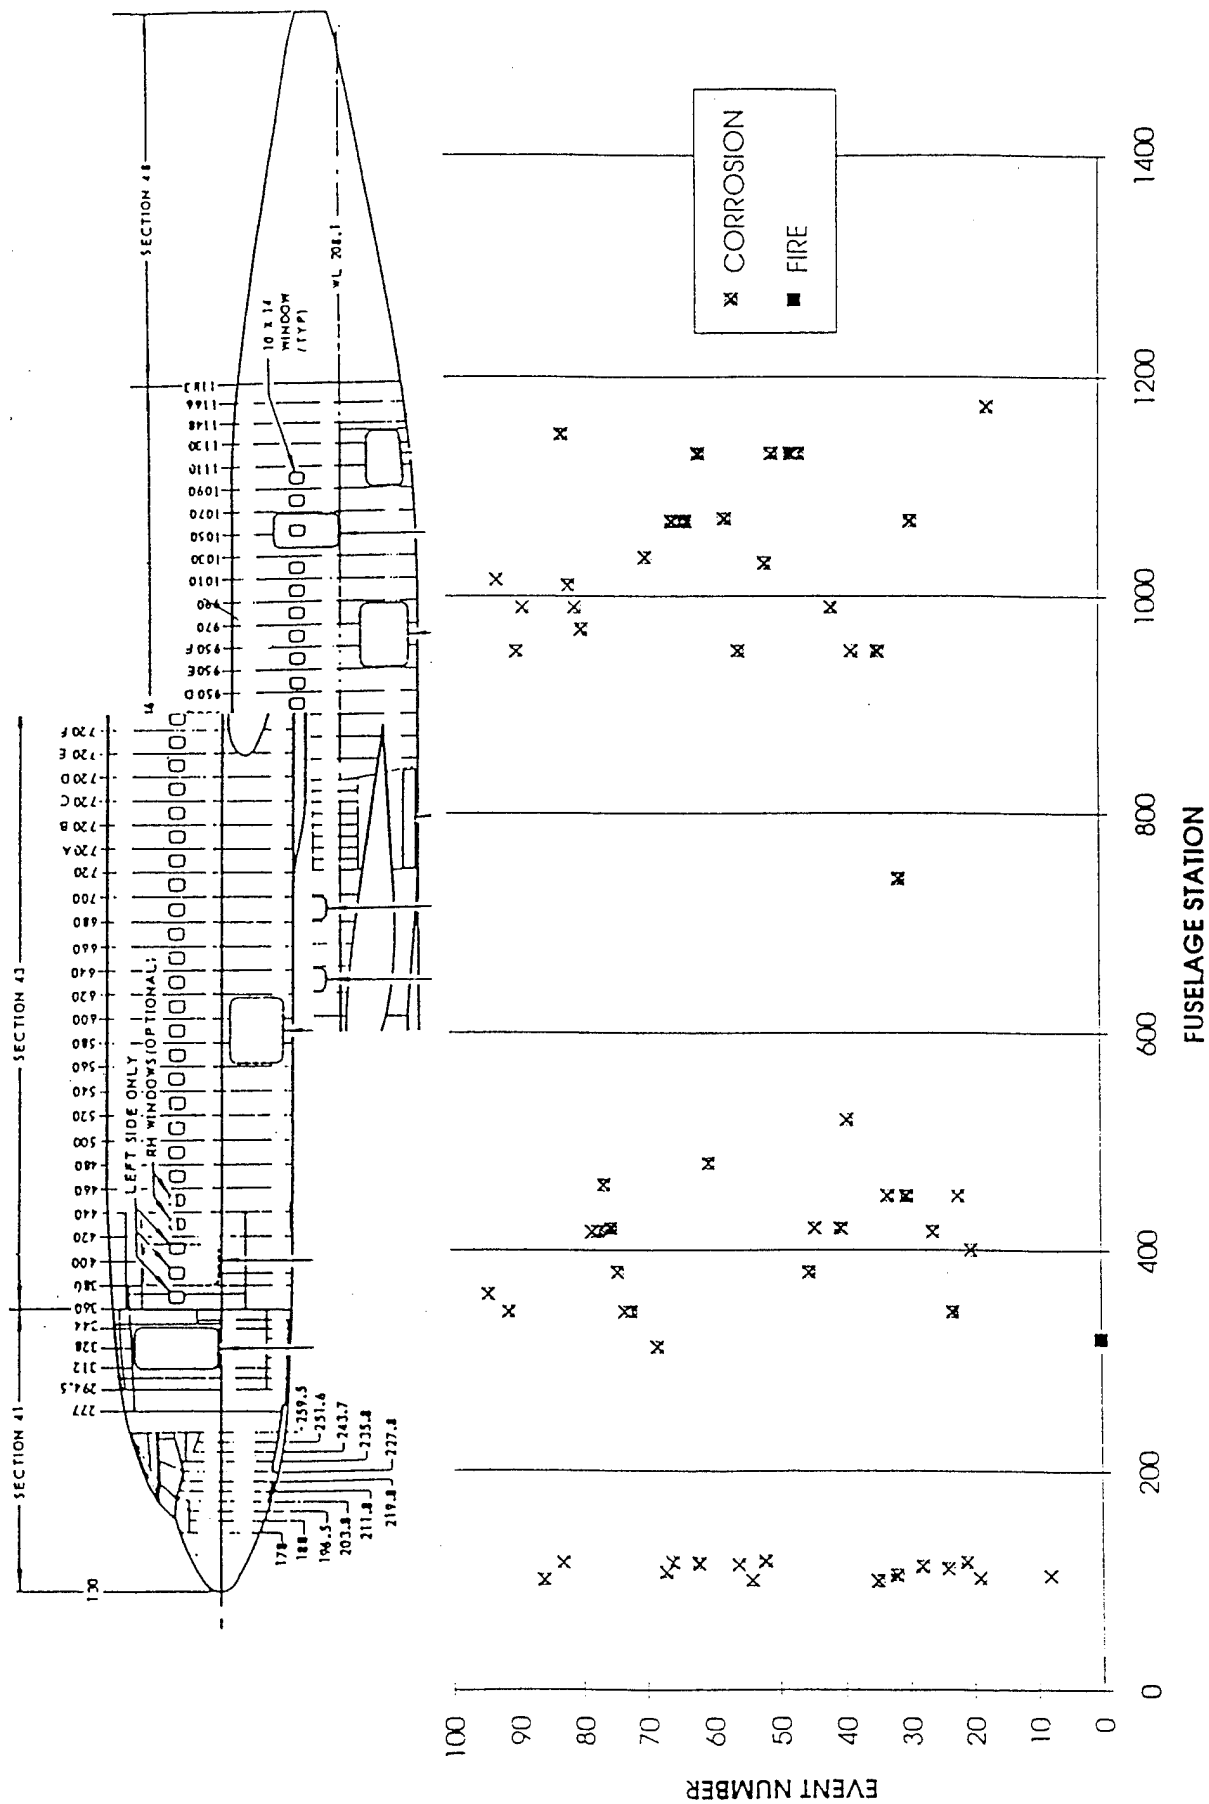
FIGURE 2. B727, S/N 21483: CORROSION AND FIRE SDRs AS A FUNCTION OF FUSELAGE STATION

Mapping of interior fuselage corrosion locations and the fire location are shown in figure 2 for this aircraft. Nineteen corrosion events are shown within 200 inches of the fire. Data contained in the nineteen corrosion reports does not establish a definite relationship between the fire and corrosion. Mapping of corrosion location versus fire location for the other aircraft indicated no concentration of corrosion at or near the fire site.

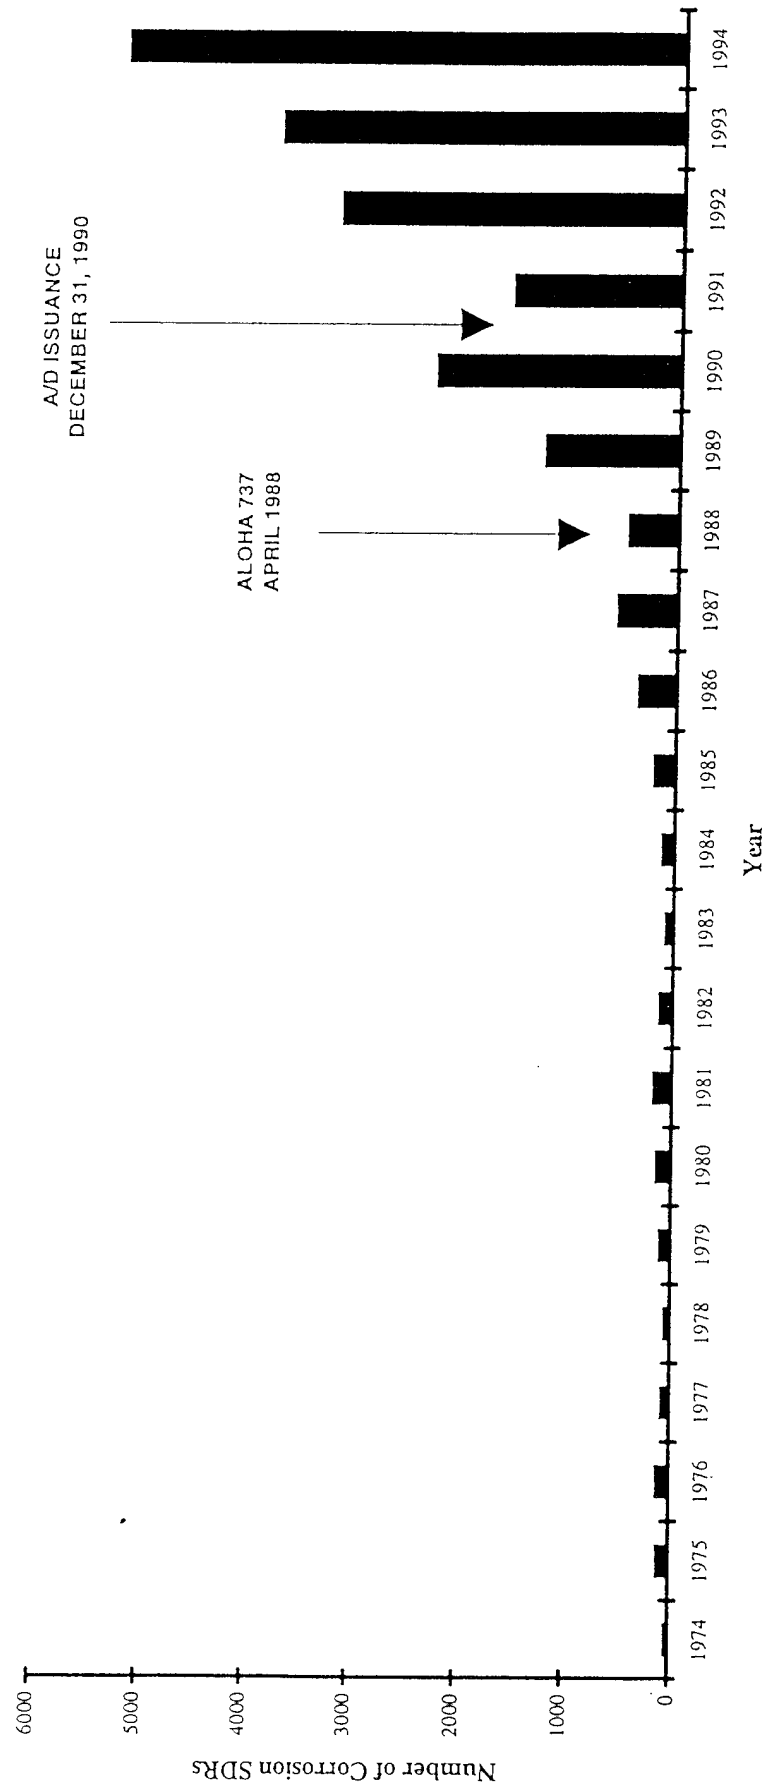
FIGURE 3. FLEETWIDE CORROSION REPORTING HISTORY FOR THE BOEING 727 AIRCRAFT

Fleetwide trends in aircraft corrosion were studied to see if aircraft with fires stand apart from overall fleet trends. It was found that on average the corrosion reporting for the 727 fleet has been low but has been increasing since 1984 when the first 727 became twenty years old. Figure 3 and table 5 illustrate this trend versus calendar time. Figure 4 highlights 1988 through 1994 and includes total fleet size and total aircraft over twenty years of age during that period. The aircraft aging trend is relatively flat and doesn't fully explain the increase in corrosion SDRs. A possible explanation as indicated on figure 4 might be increased corrosion awareness due to the Aloha incident (Boeing 737 fuselage failure) and the issuance of the Aging Aircraft Corrosion inspection ADs (table 2).

The conclusion is that when considered against the fleetwide trend in corrosion reporting, the corrosion of the fire damage aircraft cannot be attributed to fire, but is more likely due to aircraft aging and the aging aircraft inspection initiatives.
